ESL-TR-80-45

FLUSH AM-2 MAT PATCH FOR RAPID RUNWAY REPAIR

JAMES L. GREENE

SEPTEMBER 1980

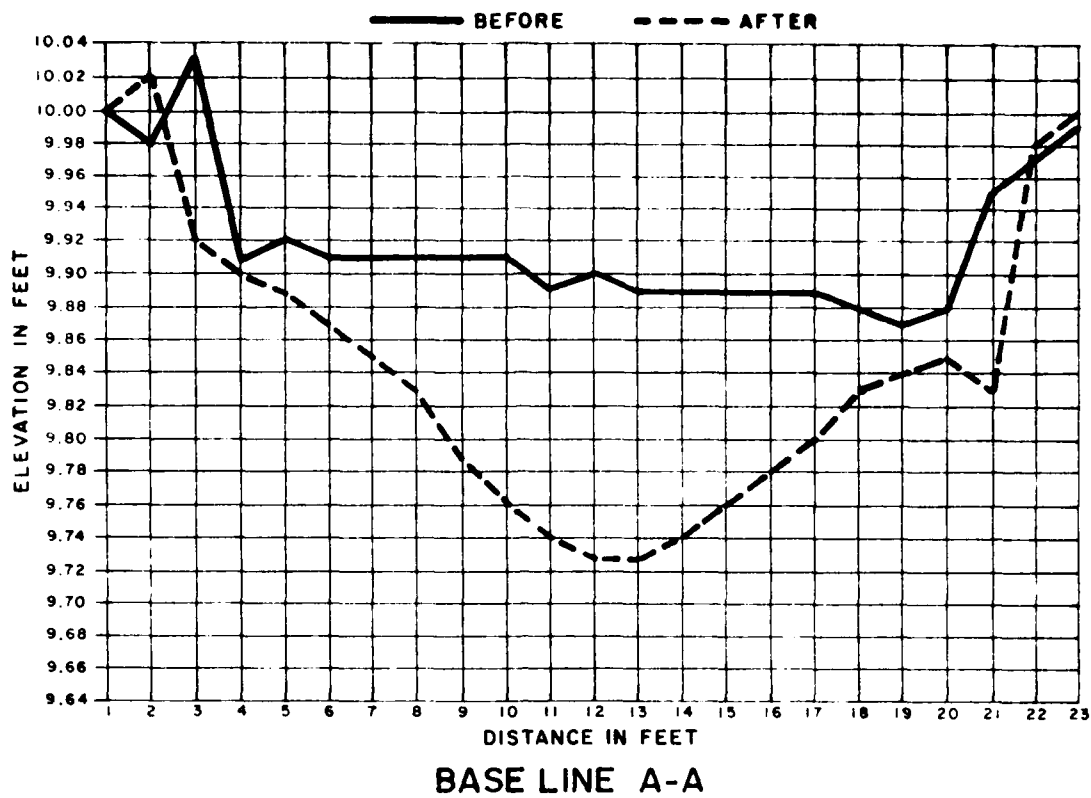
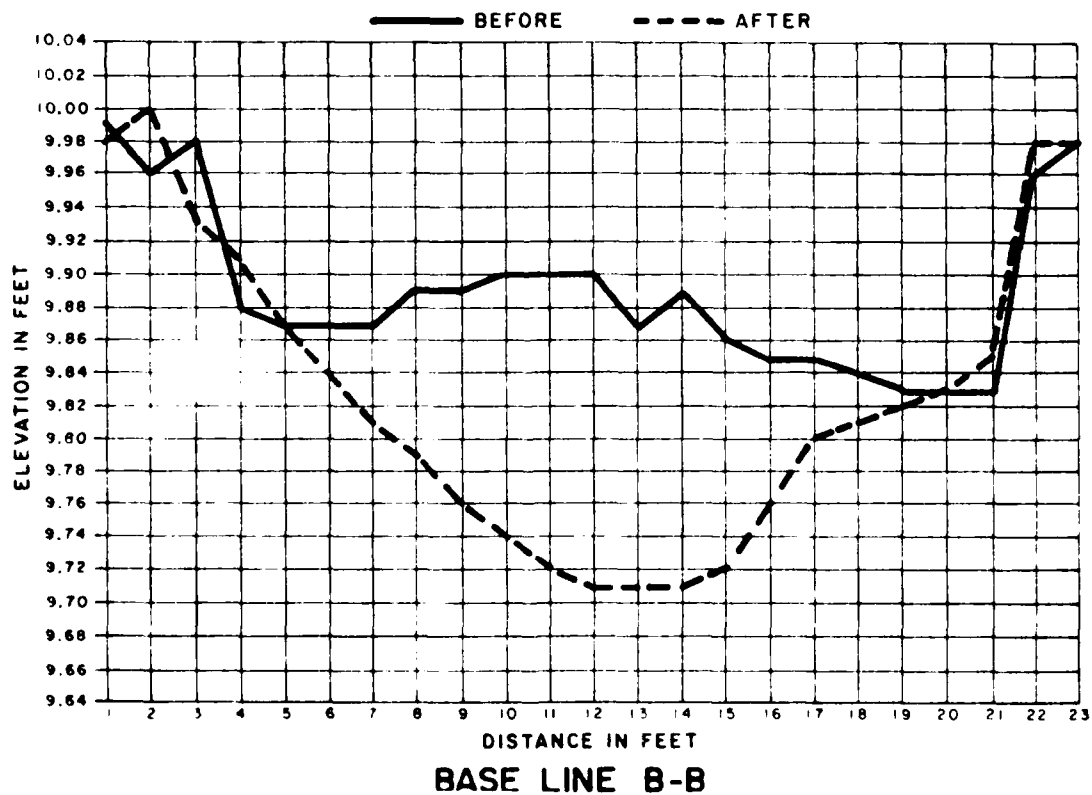
Figure 26. Coverages on Z-Clip System,
150 Cov. F-4/20 Cov. C-141,
Base Lines A-A and B-B

(7) 126 Coverages: Structural failure of the patch had occurred. The Silikal® was badly spalled with 3- or 4-inch pieces readily removed by hand. A sizeable deflection of the panels was noted as the load cart crossed.

(8) 150 Coverages: Repaired area had minor spalls. The nail holes had enlarged to such an extent that the clips were no longer bonded to the AM-2 panels. However, the patch was considered to be functional.

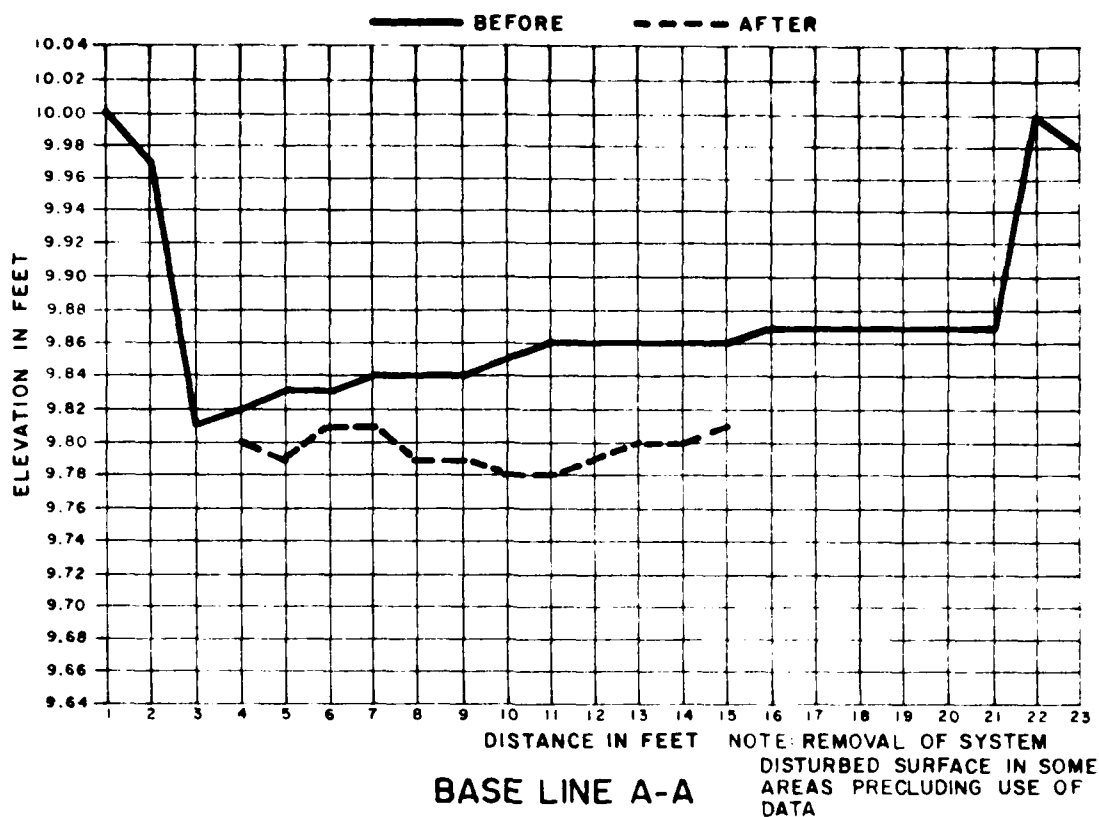
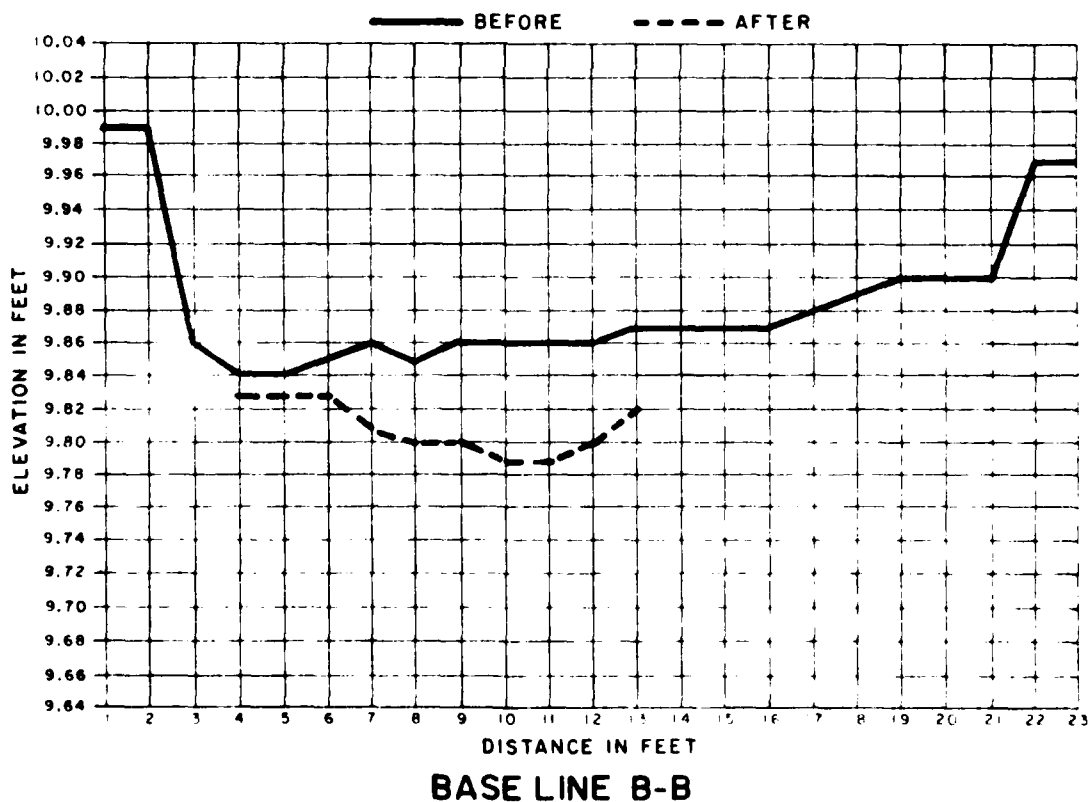
Figure 47. Coverages on Perimeter Rail System, F-4 Aircraft, 60
Coverages, Base Lines A-A and B-B

It was apparent immediately after trafficking began with the F-4 load cart that this system was weak. The rail, resting directly on the subgrade, settled after a few coverages causing the load cart to bounce as it came on or off the patch. This also exposed the sharp edge of the concrete posing possible damage to the F-4 tire. It was noted that after 20 coverages there were several short tears where the extrusion was welded to the ends of the panels. There was about a one inch lip at the edge of the concrete. Failure was determined at 60 coverages due to the amount of deflection of the rail and the resulting possibility of tire damage. Since failure occurred in the early stages of testing with the F-4, the C-141 trafficking was not accomplished.

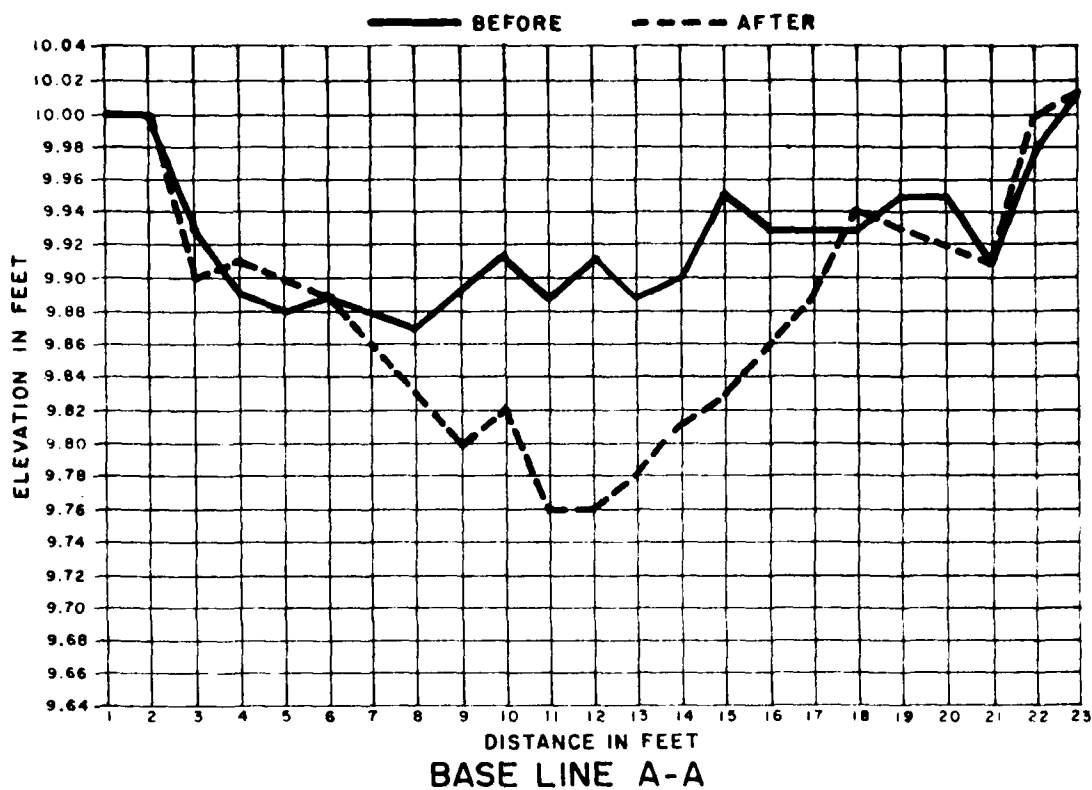
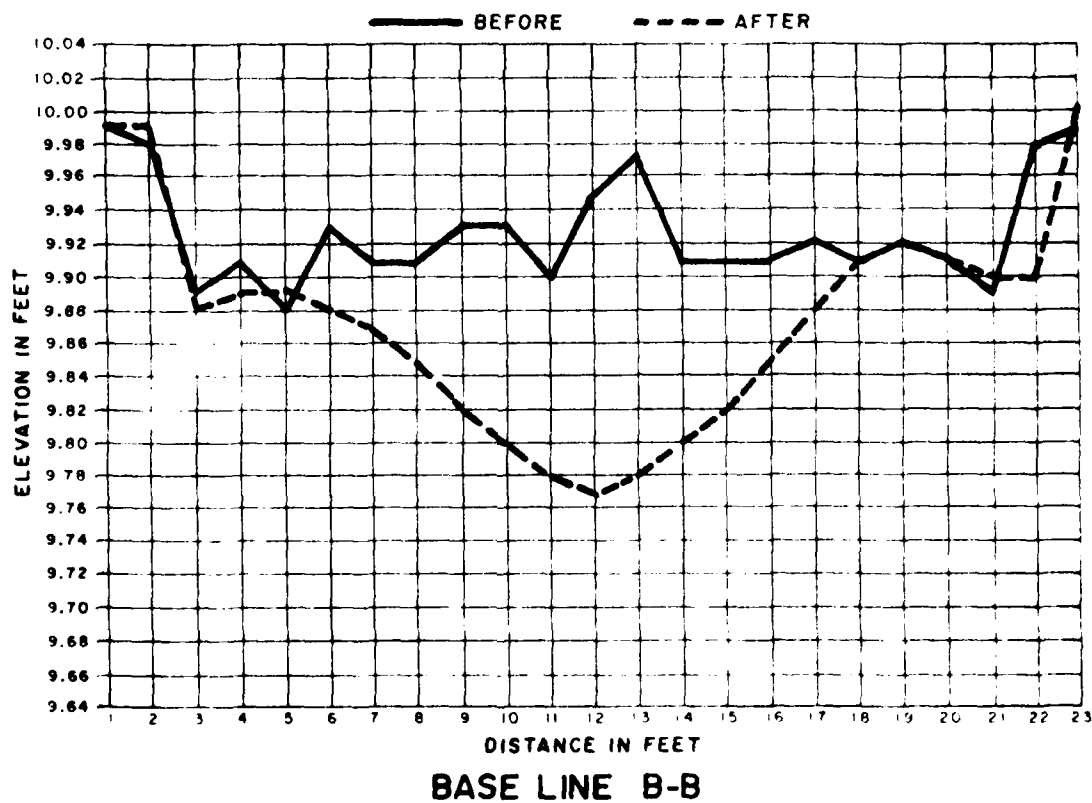
Figure 82. Coverages on Modified Side Panel System, 60 Cov. F-4, Base Lines A-A and B-B

Considerable consolidation was noted after ten coverages of the F-4 load cart. The side angles were bending towards the center and, as a result, bending the back plate of the locking assembly. After 20 coverages the nails were beginning to pull out. It appeared the base course was being pushed out of the traffic lane and mounding on the sides. At 40 coverages the angle and assembly were experiencing considerable deflections, indicating the nails had pulled out of the concrete. This caused the load cart to bounce as it came off the edge of the concrete. Sufficient deflection had taken place at 60 coverages that the patch was determined to have failed. Observations made during removal of the patch are as follows:

- (1) The locking assembly was bent considerably in the traffic lane allowing the angle to be easily removed.
- (2) The base course in the traffic lane was well compacted; however, outside the traffic lane the material was very loose.
- (3) The nails in the traffic lane had broken loose.
- (4) The 1/4-inch projection came off the angles as they were being removed.
